# National Register of Historic Places Registration Form

Historic name: Loleta Recreation Area

City or town: Millstone Township State: PA County: Elk

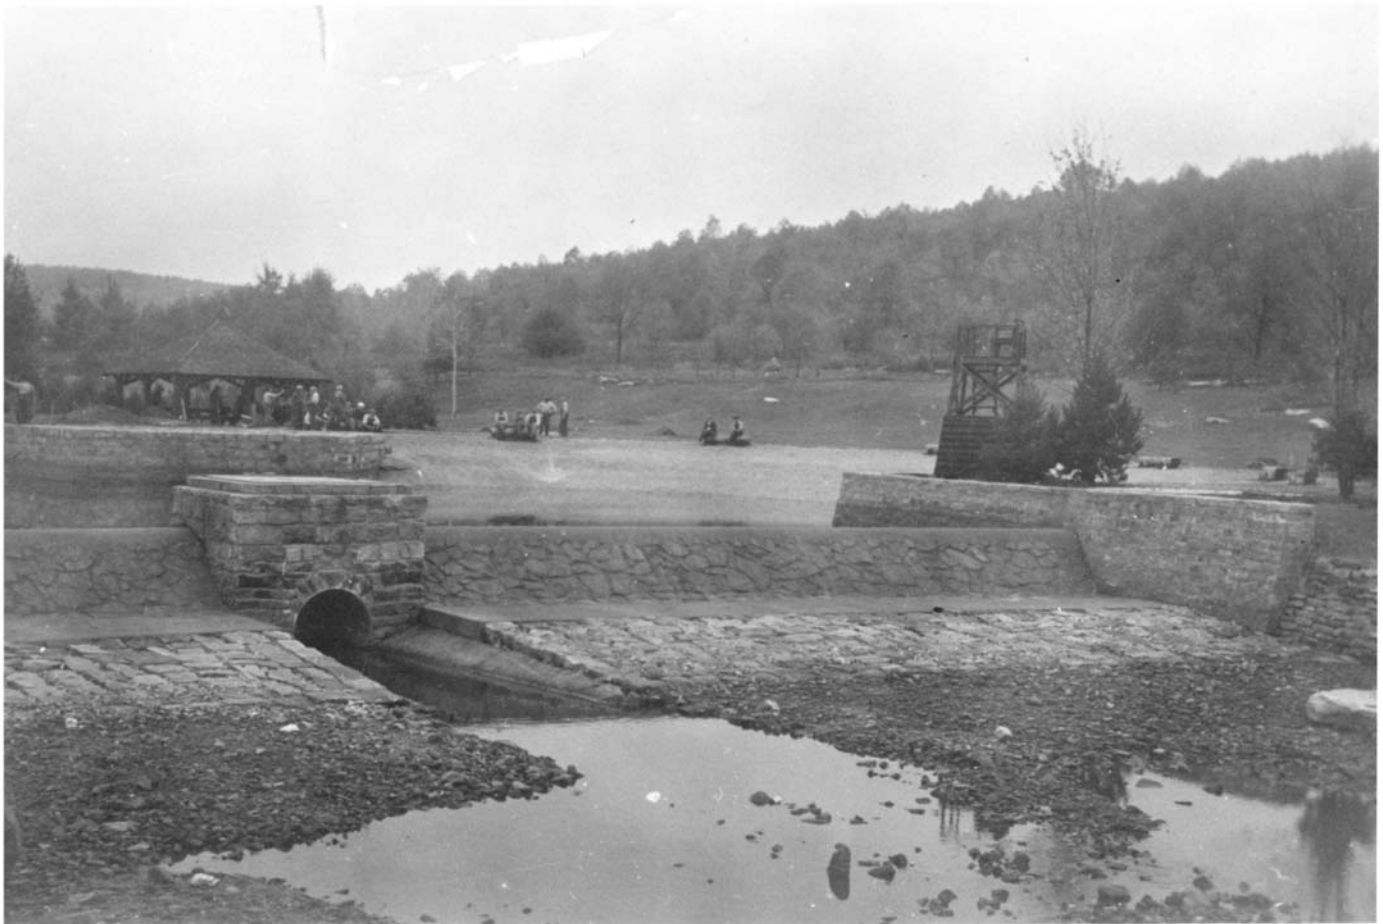
Figure 4: 1933 view of lower dam at Loleta Recreation Area. From HABS PA 5963, online, <http://www.loc.gov/pictures/resource/hhh.pa2801.photos.357189p/>, accessed April 1, 2015.

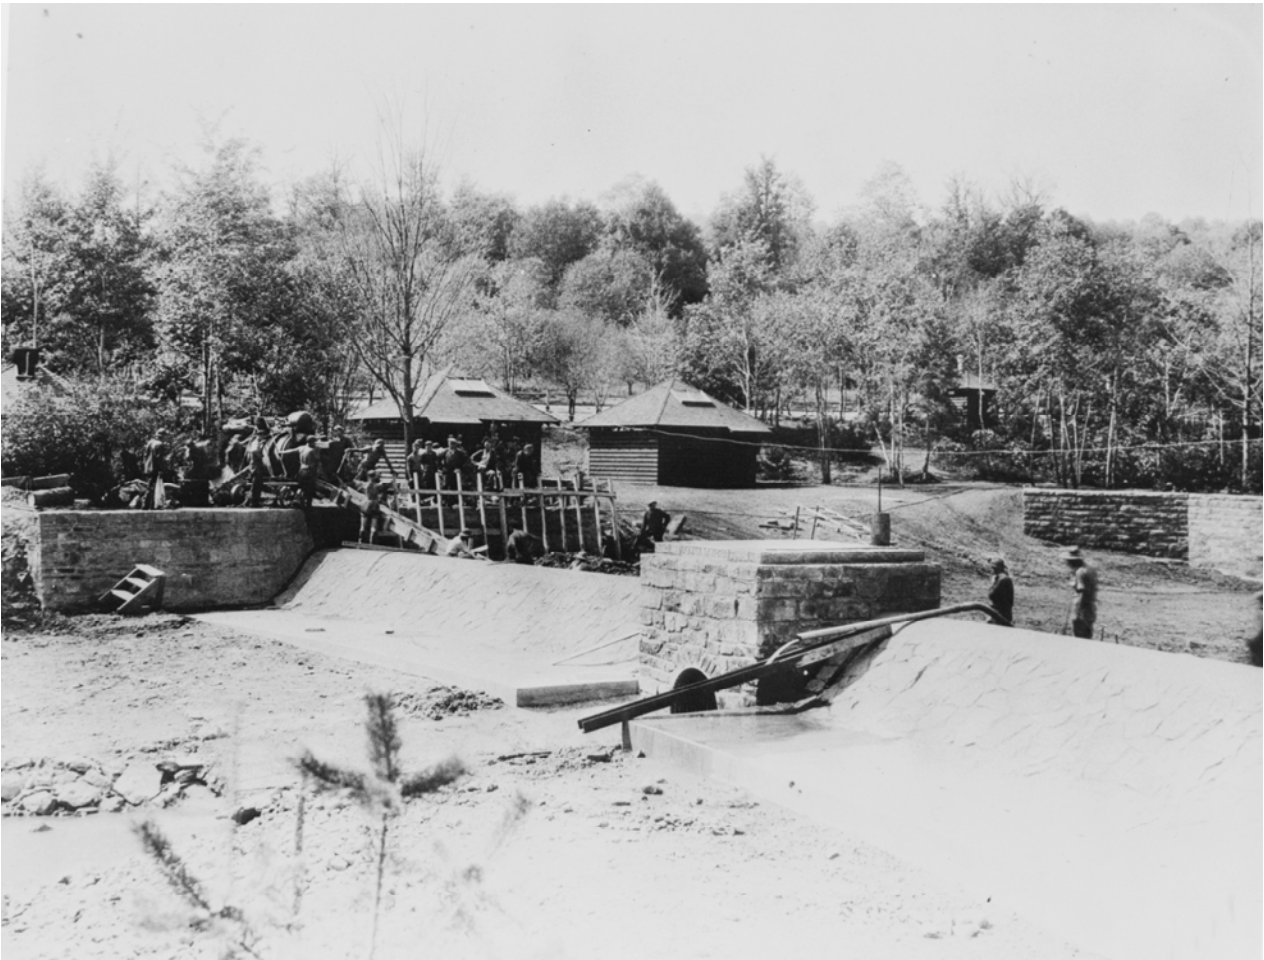
Figure 5: Ca. 1933 view of original men's and women's bathhouses at Loleta Recreation Area. From HABS PA 5963, online, <http://www.loc.gov/pictures/item/pa2801.photos.357186p/>, accessed April 1, 2015.

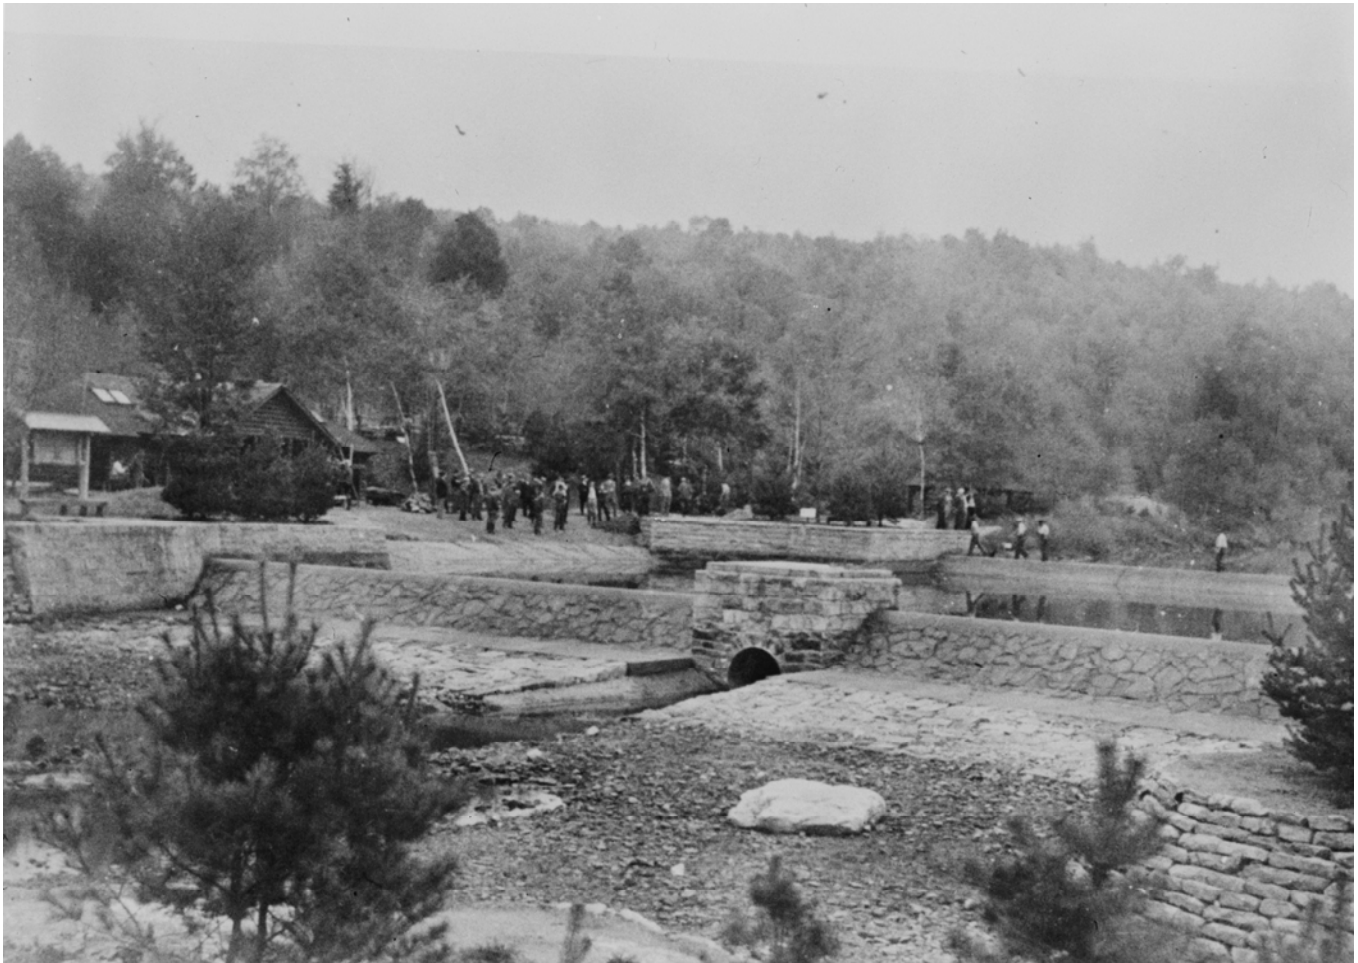
Figure 6: Ca. 1936 view of joined men's and women's bathhouses at Loleta Recreation Area. From HABS PA 5963, online, <http://www.loc.gov/pictures/item/pa2801.photos.357188p/>, accessed April 1, 2015.

The CCC-built bathhouse is an excellent example of the high quality construction of the CCC (Photos 1, 5, 11, and 17). The building sits on a concrete base and measures forty-eight feet, ten inches by fifteen feet, eleven inches. It consists of half-logs of uniform shape and sizing set in a horizontal pattern to form the exterior of the structure. The roof, which is covered in asphalt shingles over original cedar shingles, is hipped with a projecting center cross-gable supported by four log columns. The original fenestration and wane-edged siding of the bathhouse are all present today. Originally the east and west portions of the bathhouse were two separate changing facilities for men and women (Figure 5). In 1936, however, a center section was added to combine the two buildings (Figure 6 and 7). This middle section housed toilets and sinks.

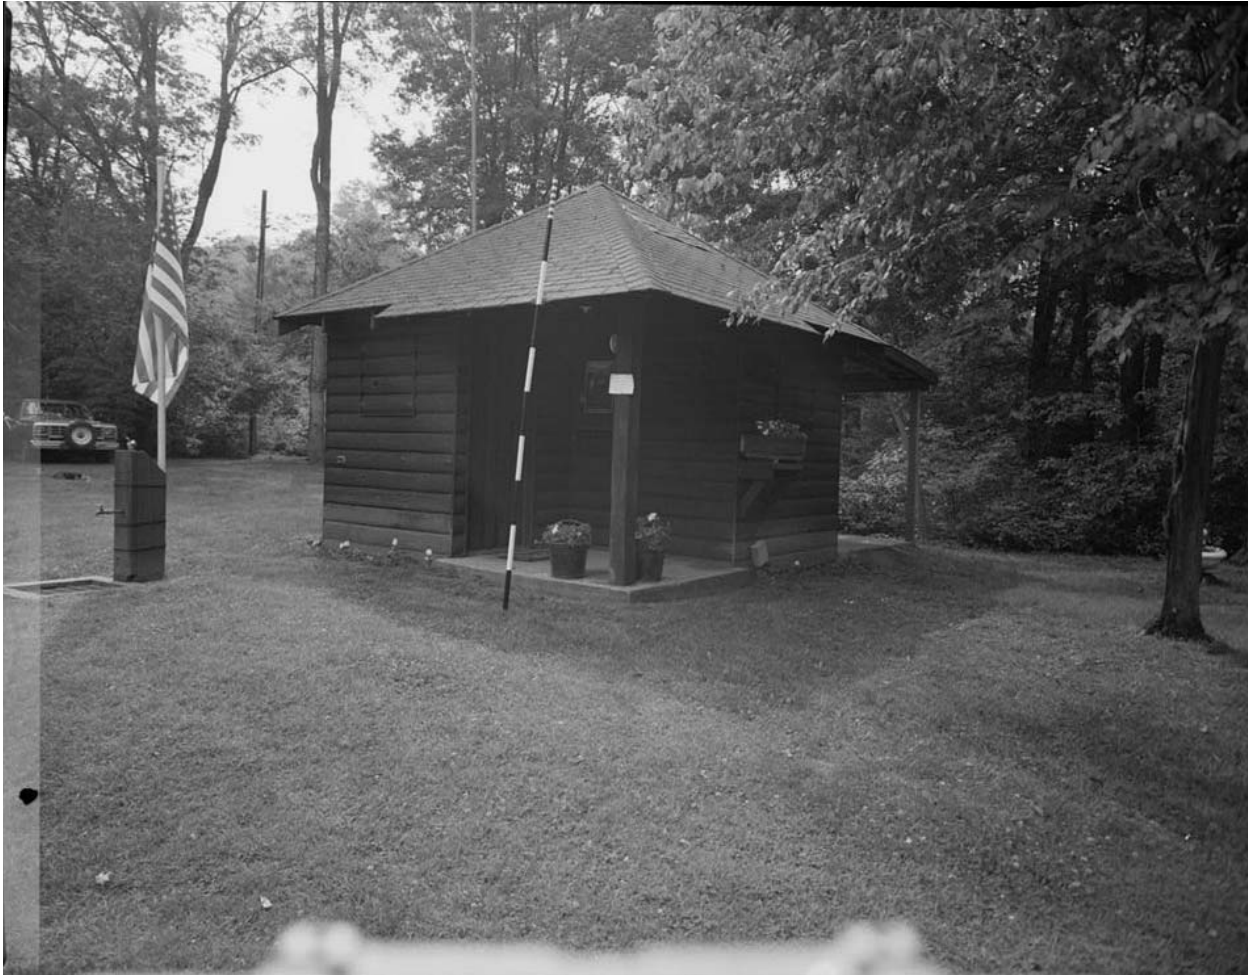
Figure 10: 1993 photo of the office/tool shed. From HABS PA 5963, online, <http://www.loc.gov/pictures/item/pa2804.photos.357223p/resource/>, accessed April 1, 2015.

The office/tool shed (Figure 10) was removed in 1994 due to wear and tear on the structure.<sup>7</sup> It was originally designed to hold construction tools, but was later converted into an office building. Its loss does not greatly impact integrity because it was a small-scale resource built to house workers' tools, and it was not strongly associated with recreation. In addition, when it was converted to an office, it was used only to hold maps and house a person to provide assistance to

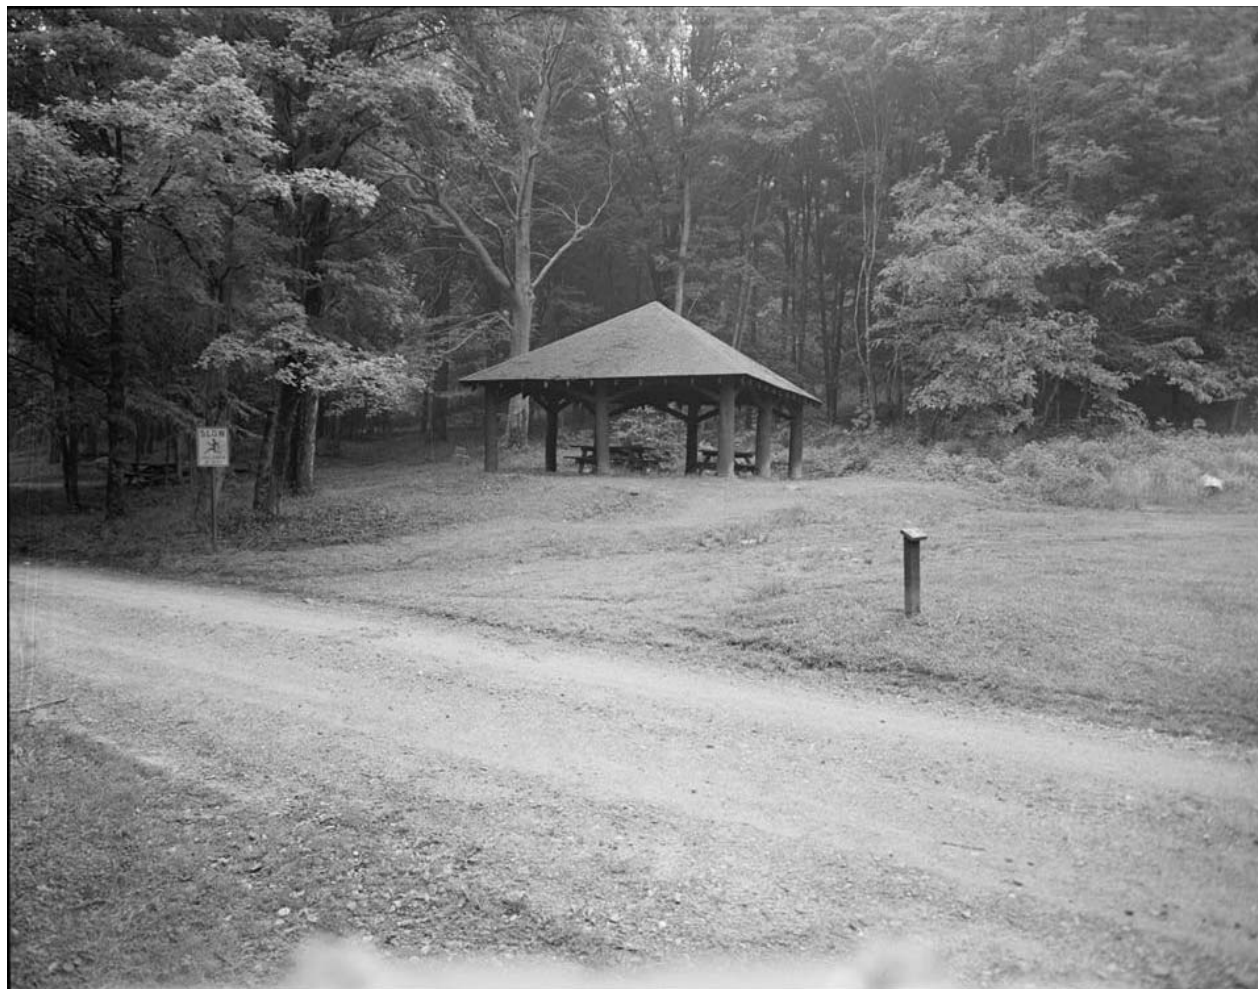
Figure 11: 1993 photo of picnic pavilion A. From HABS PA 5963, online, <http://www.loc.gov/pictures/item/pa2801.photos.357181p/>, accessed April 1, 2015.

integrity because the replacement was sensitive to the original design. Removed in 1994, pavilion A (Figure 11) would have been constructed similarly.<sup>6</sup>

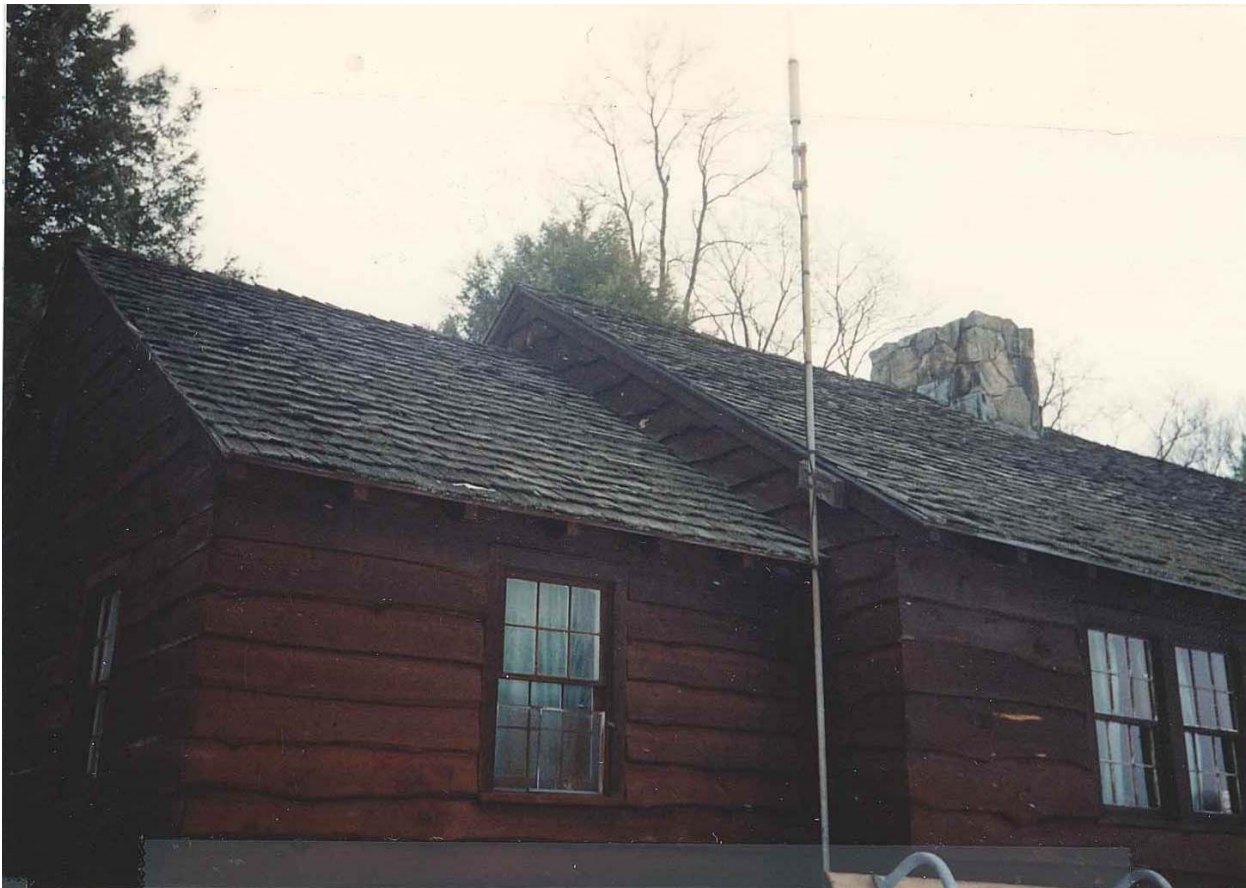
Figure 13: 1992 photo of Twin Lakes Forest Camp bathhouse. From historic resource survey file for Twin Lake Bath House, on file, Harrisburg PA: Bureau for Historic Preservation.

In terms of recreation, Twin Lakes was much larger than Loleta; however, unlike Loleta, it was never completed to its original plans. The original plans called for two lakes at the site (hence the name), but only one was ever completed due to budget constraints.<sup>41</sup> In fact, the unspent money at Twin Lakes was diverted to Loleta.<sup>42</sup> In addition, work at Loleta began in 1933, while work at Twin Lakes began in 1936. In terms of architecture, both Loleta and Twin Lakes were executed in the Rustic Style and both fit in with the surrounding natural environment and with the history of their sites. While half-logs were used in the construction of Loleta's bathhouse, however, the bathhouse at Twin Lakes used unfinished planed lumber for cladding (Figure 13).
